THE IMPACT OF CATTLE FEEDLOT  
OPERATION ON GROUNDWATER  
QUALITY IN THE FRACTURED  
ROCKS NEAR THE WIARTON  
SEWAGE LAGOON

THE IMPACT OF CATTLE FEEDLOT OPERATION  
ON GROUNDWATER QUALITY  
IN THE FRACTURED ROCKS NEAR THE  
WIARTON SEWAGE LAGOON

by  
Blagoje Novakovic, P.Eng.

SOUTHWESTERN REGION  
TECHNICAL SUPPORT SECTION  
LONDON

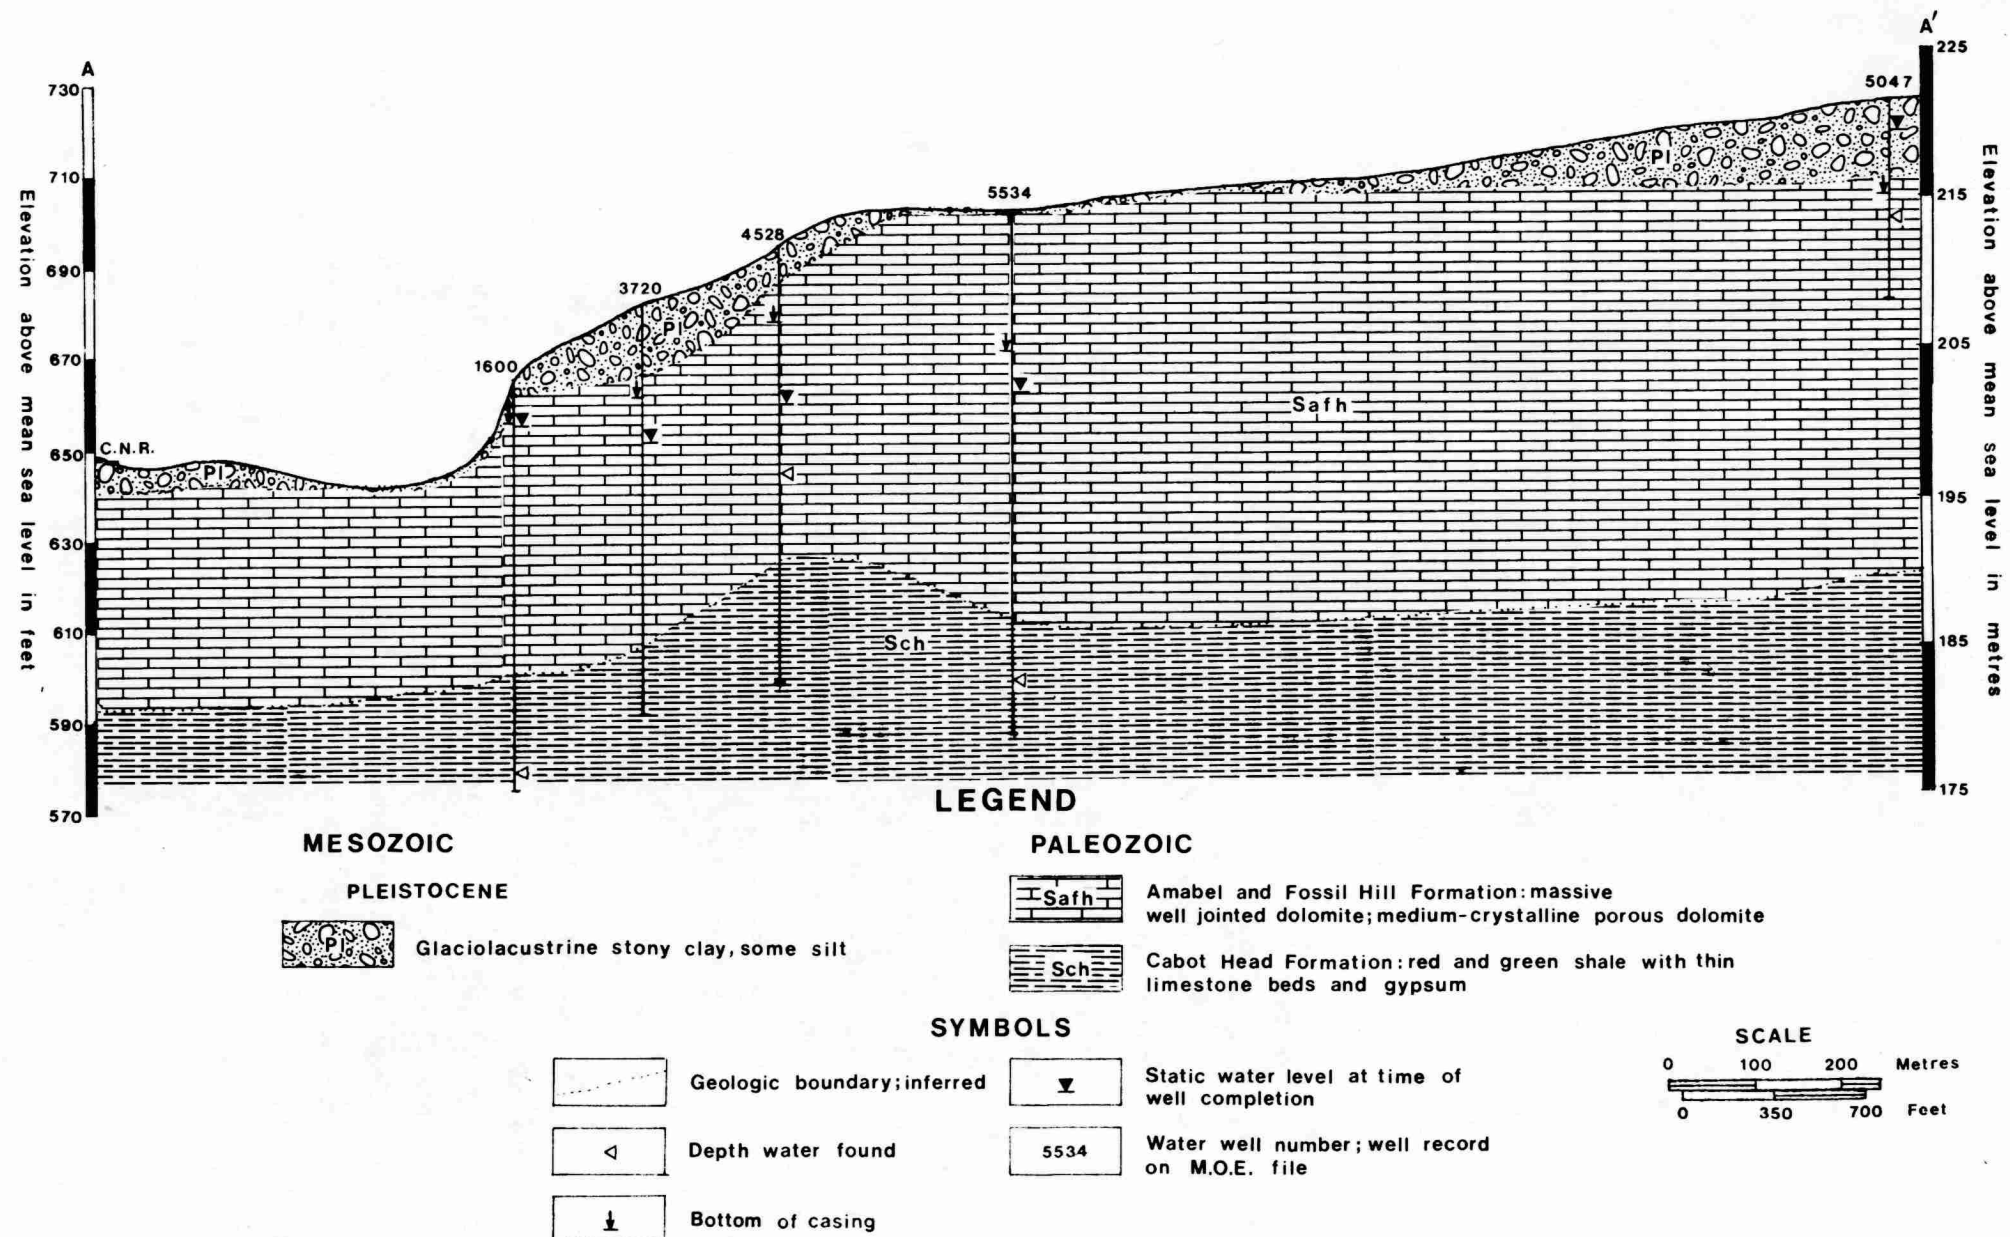
FIGURE 2. VERTICAL CROSS - SECTION A-A' SHOWING GEOLOGY AND HYDROGEOLOGY OF THE STUDY AREA.

Section location is shown in Figure 1.

Figures 2 and 3 indicate the distribution of lithologic units in the study area. Several local domestic wells report water from the Cabot Head Formation (Appendix A) which consists of soft, red, and green shale with thin limestone and gypsum beds. Generally, water from this formation is of poor quality (very hard) containing increased concentrations of sodium, chloride, sulphate and potassium. Overlying this formation are the Amabel and Fossil Hill Formations which consist of massive and bedded, well jointed, medium crystalline, porous dolomite (Plate 1). Several small sinkholes are developed in these formations (Plate 2). Several domestic wells in the area obtain water from the upper portion of this lithologic unit (Appendix A, Figures 2 and 3) and two springs (used for water supply) originate in this shallow bedrock aquifer. Spring 1 (Plate 3) serves the domestic requirements of Mrs. G. Armstrong and Miss V. Baker and spring 2 (Plate 4; owned by Mr. R. Boulter) is used for stock watering purposes. Numerous other springs occur along the toe of the Niagara Escarpment (Figure 1) forming a "spring line" which probably marks the contact between the dolomites (Amabel and Fossil Hill Formations) and the poorly permeable underlying shales (Cabot Head Formation).

The overburden is very thin and in many areas it is absent, particularly in the central and west-central portions of the study area. Near the Boulter and the Armstrong springs, the soil is very shallow with much bare rock exposed (Plates 3 and 4). In the eastern portion of the study area, a considerable increase in overburden thickness is reported in water well records where up to 6 m of stoney, clayey silt till is present (Figure 2).

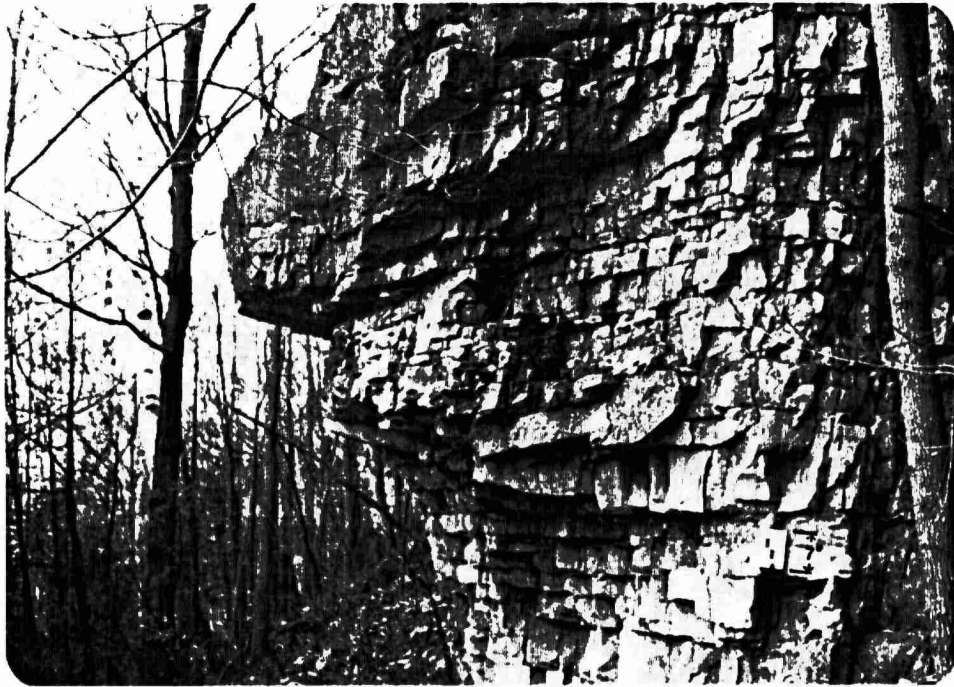
Plate 1. Massive and horizontally bedded, fractured dolomite of the Amabel and Fossil Hill Formations is well exposed on the Niagara Escarpment.

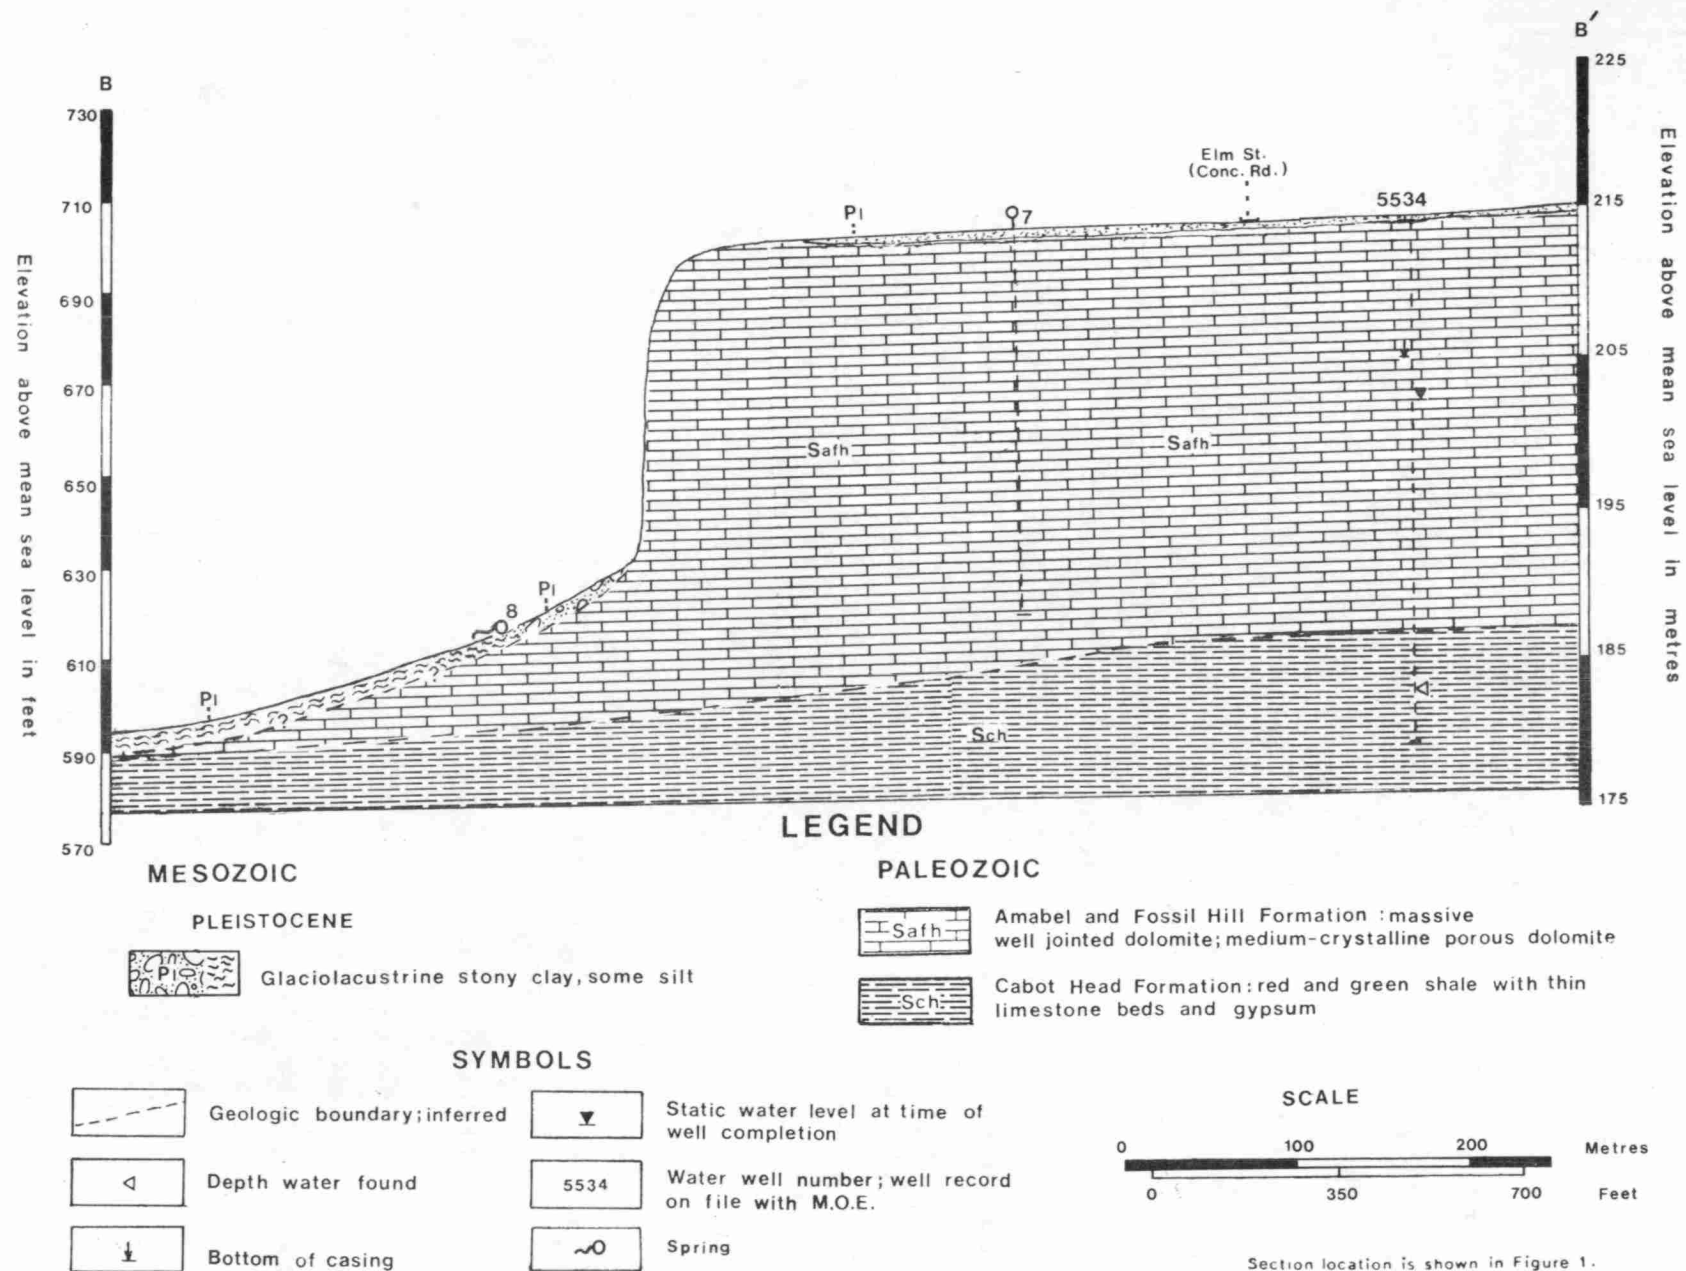
FIGURE 3. VERTICAL CROSS - SECTION B-B' SHOWING GEOLOGY AND HYDROGEOLOGY OF THE STUDY AREA.

The Amabel and Fossil Hill Formations (and the groundwaters they contain) are considered to constitute the shallow bedrock aquifer (Figures 2 and 3). Several springs which occur at the base of the escarpment (Figures 1 and 3) discharge from this carbonate aquifer system. Additionally, there are also several drilled wells completed into this shallow fractured rock aquifer (wells 1, 2, 3, 4, 5047).

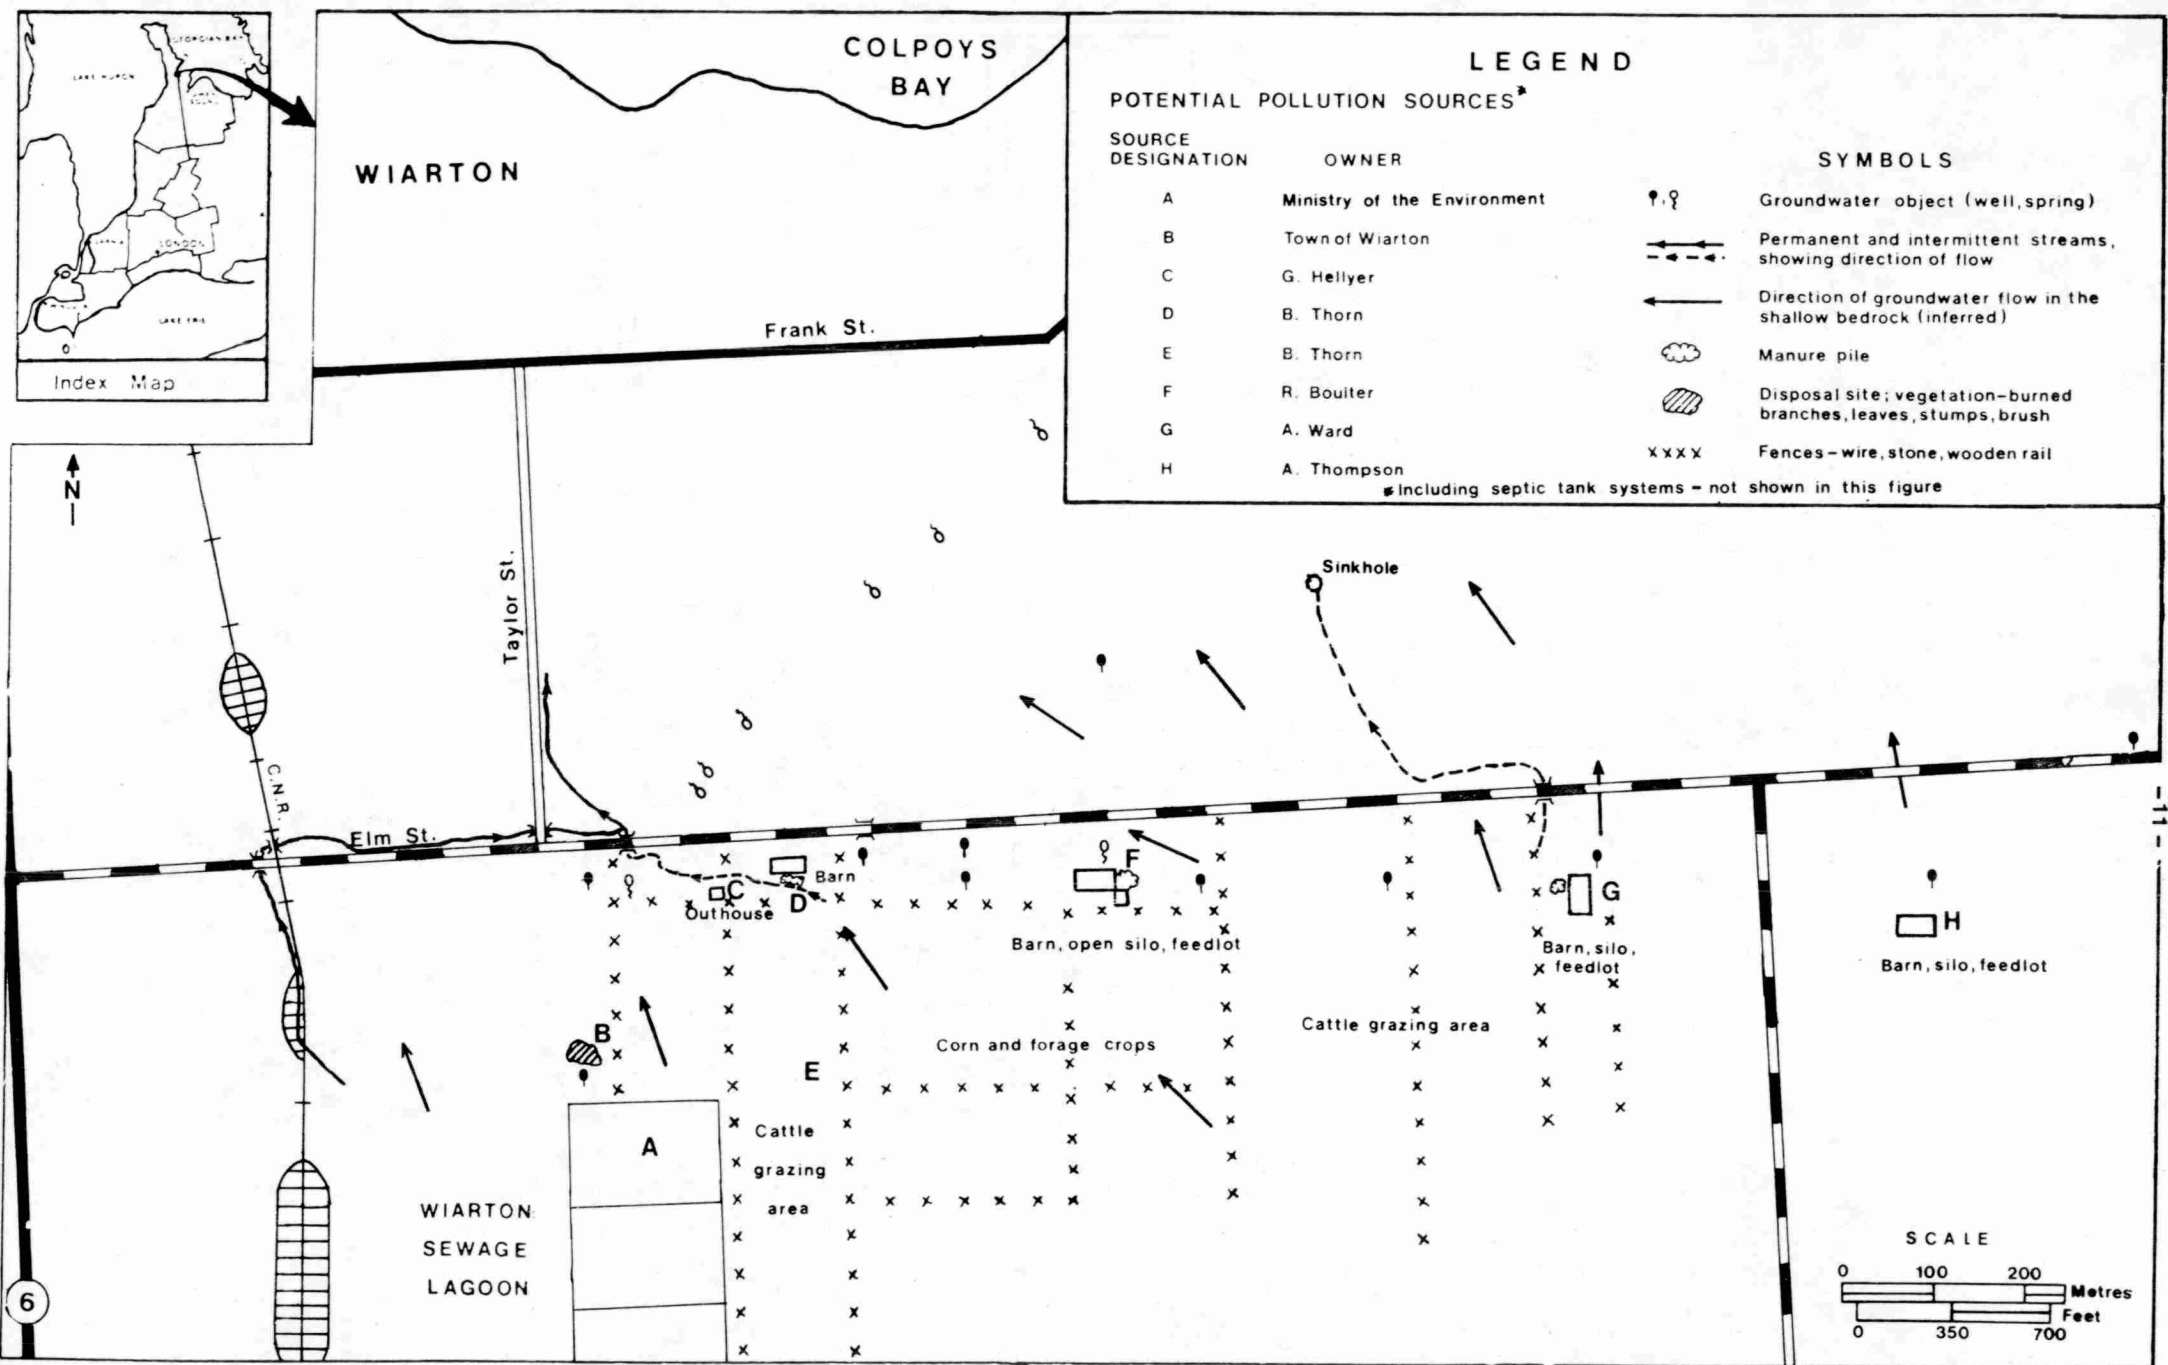
FIGURE 4. POTENTIAL POLLUTION SOURCES AND GROUNDWATER FLOW DIRECTION IN SHALLOW BEDROCK.

The movement of groundwater in fissured and fractured dolomite is greatly influenced by the orientation of the fracture patterns. Although no systematic measurements of these patterns was carried out, observations indicate that the chief direction of the main fractures is NW to SE. The direction of the surface water drainage pattern is similar. These factors were considered together with field observations in determining the direction of groundwater movement in this water-bearing zone (Figure 4).

Figure 4 locates potential sources of pollution. Cattle grazing areas constitute diffuse sources of pollution, while the remainder are considered point sources. Point sources located in areas where the overburden is very thin or absent (locations designated as C, D and F in Figure 4) are considered greater threats to groundwater quality than are the other sources. Where the overburden is thin or absent, there is little attenuation of pollutants because the travel paths of pollutants are relatively short before reaching the fractured rock and the groundwater. Furthermore, ionic exchange, fixation and other attenuating processes are negligible in fractured rock.

The contributions to the deterioration of water quality in the Armstrong springs from the two other nearby potential pollution sources (C and D in Figure 4, Plate 7) are difficult to assess accurately at this time. However,

It is unlikely that the cause of water quality deterioration in the Boulter spring is source G (Figure 4) because:

It is therefore concluded that the likely source of the Boulter spring pollution is source F as indicated in Figure 4. Bacteriological analyses suggest that the effluent from the adjacent septic tank disposal system serving the Hurlburt family might also contribute to water quality deterioration in this spring.

3. The manure piles at pollution source D (Figure 4, Plate 7) should be removed taking appropriate measures to prevent pollutants associated with this operation from infiltrating into the fractured bedrock and from entering the nearby intermittent stream.
4. Wastes in the outhouse (source C in Figure 4) should be isolated and prevented from entering the fractured bedrock.

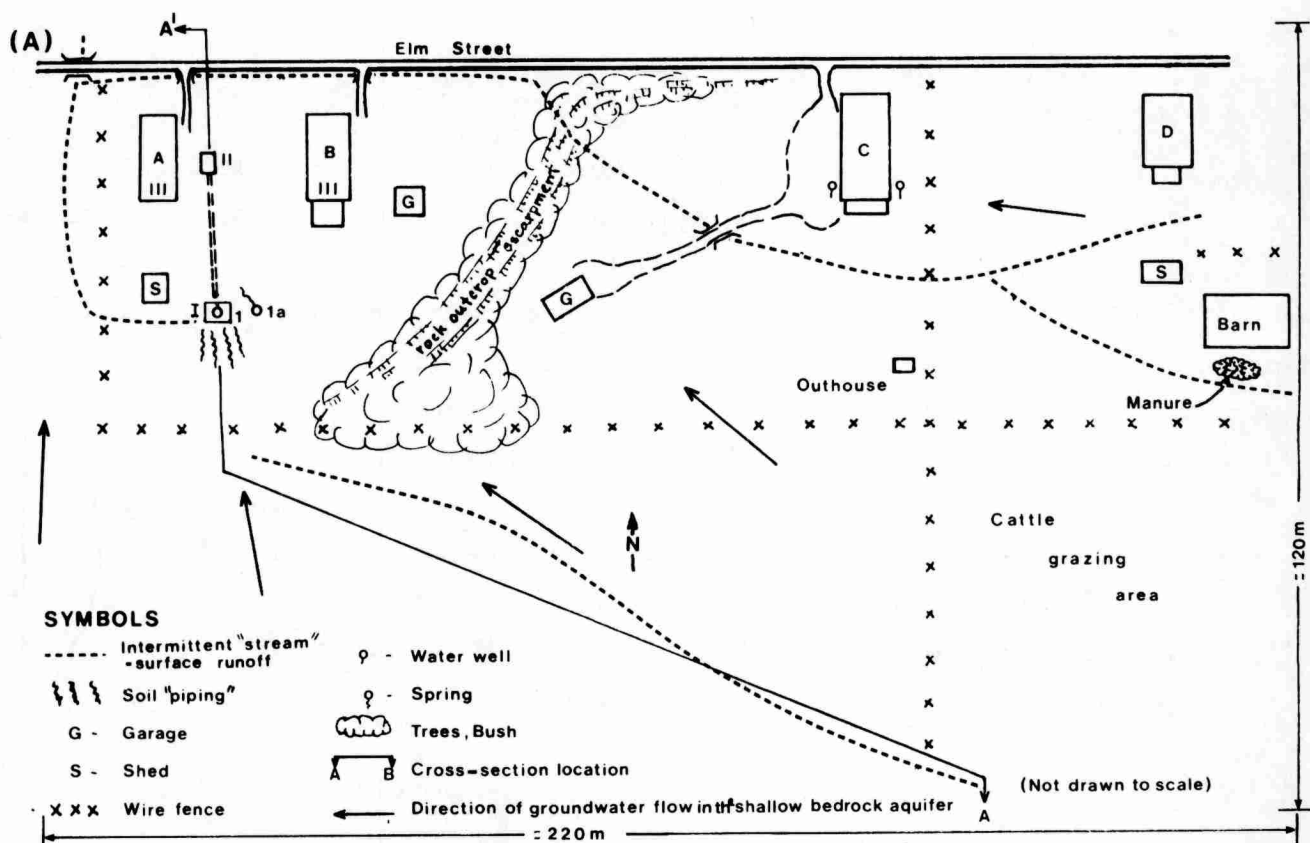
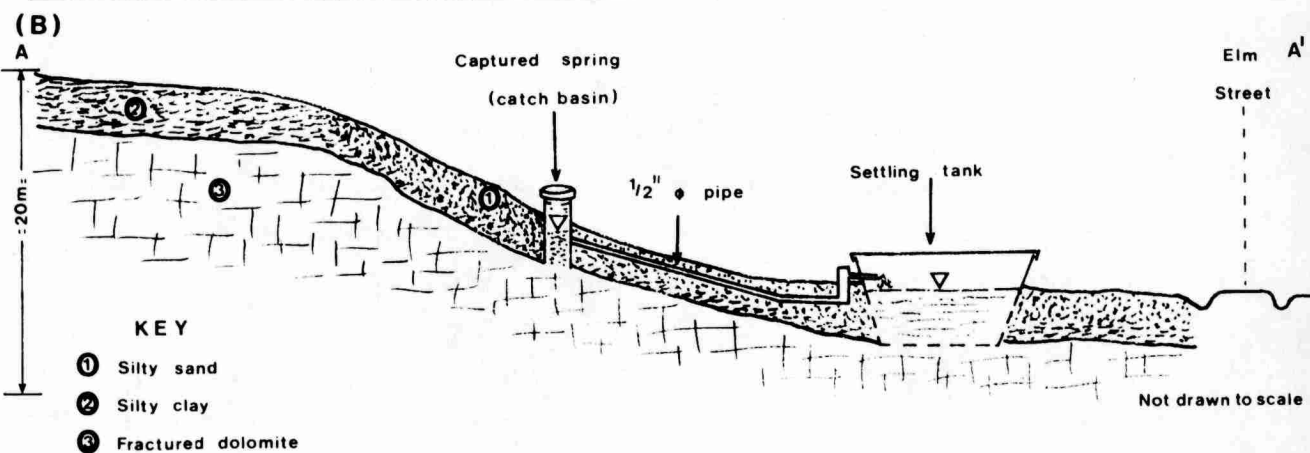
FIGURE 5. SKETCH SHOWING GENERAL LAYOUT OF MRS. G. ARMSTRONG'S WATER SUPPLY SYSTEM (A) AND VERTICAL CROSS-SECTION THROUGH THIS WATER SUPPLY SYSTEM (B).

The general layout of Mrs. Armstrong's water supply system and a vertical cross-section through her water supply sources are shown in Figure 5. A spring originating from the shallow dolomite bedrock is the source of water. At this locality, the bedrock is overlain by a few feet of overburden which consists of silt and silty and clayey sand.

It is apparent that phenols and nutrients reach their highest concentration levels in the Armstrong springs during late autumn. At this time there is an abundance of manure on the ground particularly in the cattle grazing area (potential pollution source E in Figure 4). In the early spring of 1977 after a rapid snow melt it was observed that surface water runoff originating in the area of potential pollution source E flowed towards the Armstrong spring along very shallow undulations on the ground surface (Figure 5).

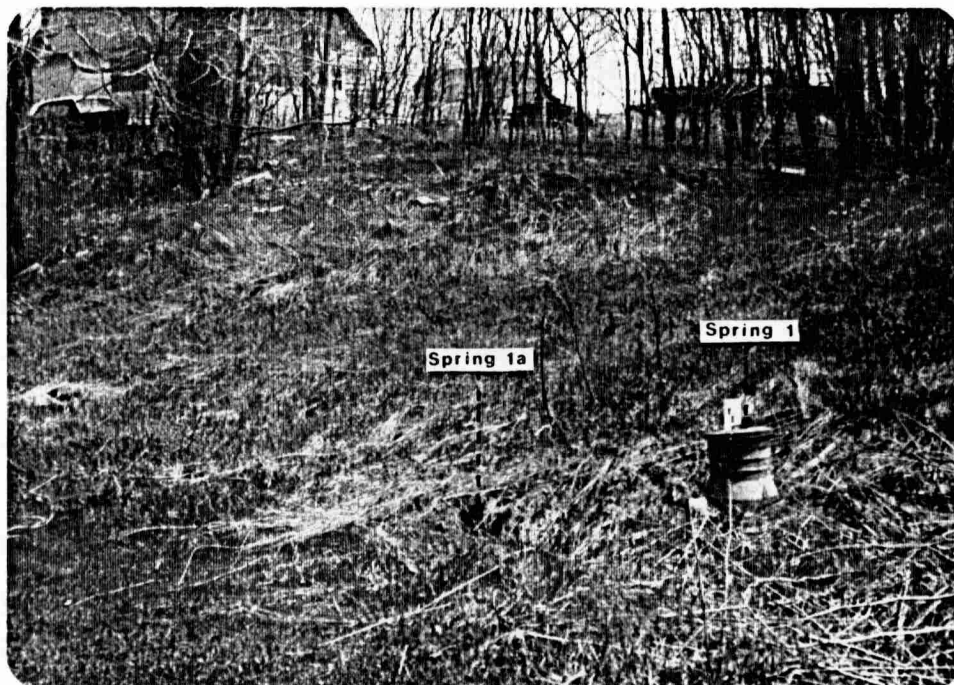
Plate 3. Looking southeast; the Armstrong springs occur below a gentle undulation on the escarpment slope. The edge of tree cover marks the line of outcropping bedrock.

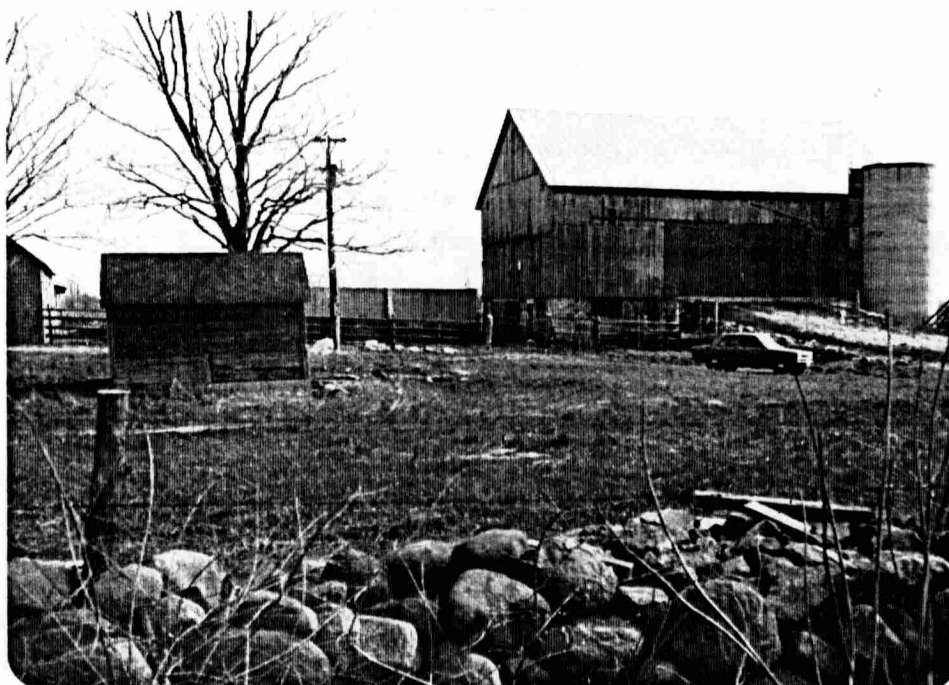
Plate 4. Looking southwest; the Boulter spring is in the foreground (shed) surrounded by several rock outcrops. The main feedlot is beyond the barn, while a smaller feedlot is on the left side of the barn.

The Boulter spring which is used for stock watering does not discharge at ground level. It has been "developed" in an elongated excavation up to 2 m in depth which intercepts groundwater that flows through fractures in the rock. A barrier has been placed in the excavation to create a pumping reservoir and water can be heard cascading over this barrier. At this locality the horizontally bedded dolomite is overlain by a thin veneer of soil, and several outcrops are present in the immediate vicinity of this spring. A fenced feedlot is located about 65 m south-southwest of this spring. The main feedlot and an open silo adjacent to it are located 90 m from the spring, immediately beyond the barn (Plate 4).

No significant runoff was observed to be leaving the Boulter feedlot (Plates 4 and 5) except on the northern side where a small amount moved a distance of about 20 m from the feedlot, before infiltrating into the ground. The reason for this is that this feedlot is unpaved and most of the liquid generated readily infiltrates into the ground.

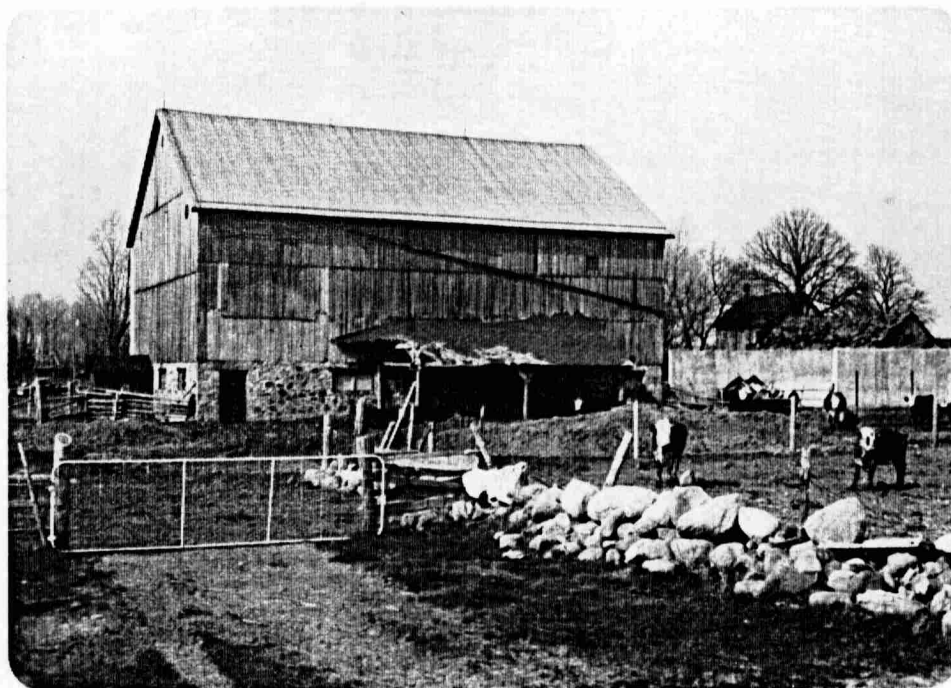
Plate 5. A typical unpaved feedlot operation. Looking northwest; the Boulter feedlot, barn, and open silo (at the right margin). The Boulter spring is behind the barn building.

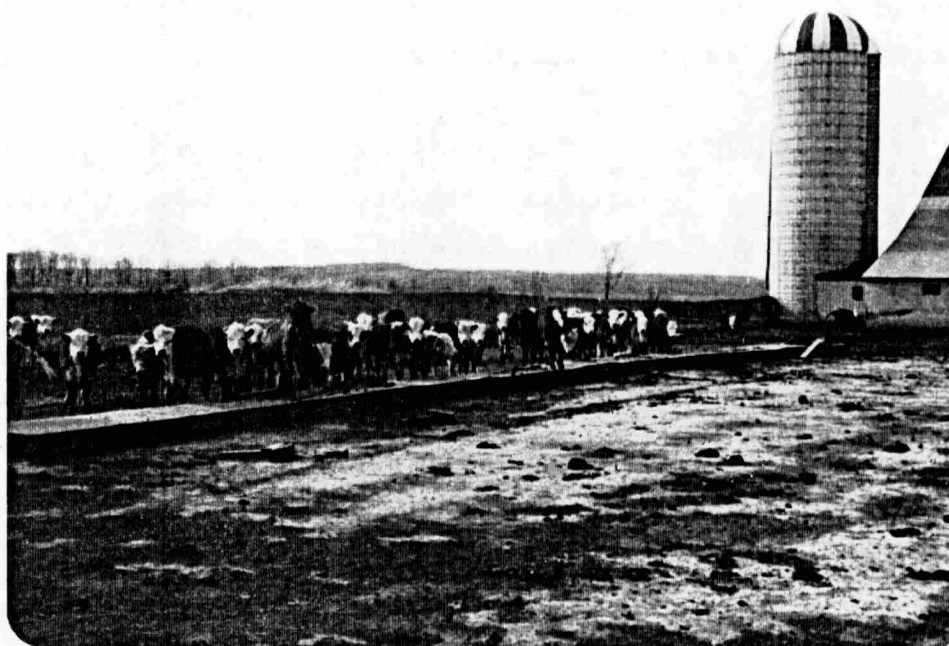
Plate 6. The Ward feedlot is paved and concrete-fenced. Looking northwest; the Niagara Escarpment (across Colpoys Bay) is in the distant background.

The Ward feedlot (Plate 6) is concrete-paved and also fenced with concrete. The runoff leaves the feedlot area at the northwestern corner forming a small pond just outside the feedlot fence. From here, it moves in westerly and northerly directions. On one occasion, runoff was observed to move about 80 m due west where it infiltrated into the ground just before reaching the first fence (Figure 4). Moving in a northerly direction, the runoff gains direct access into the intermittent stream which flows across the Wiarton airport field and terminates in several small sinkholes (Figure 4, Plate 2).

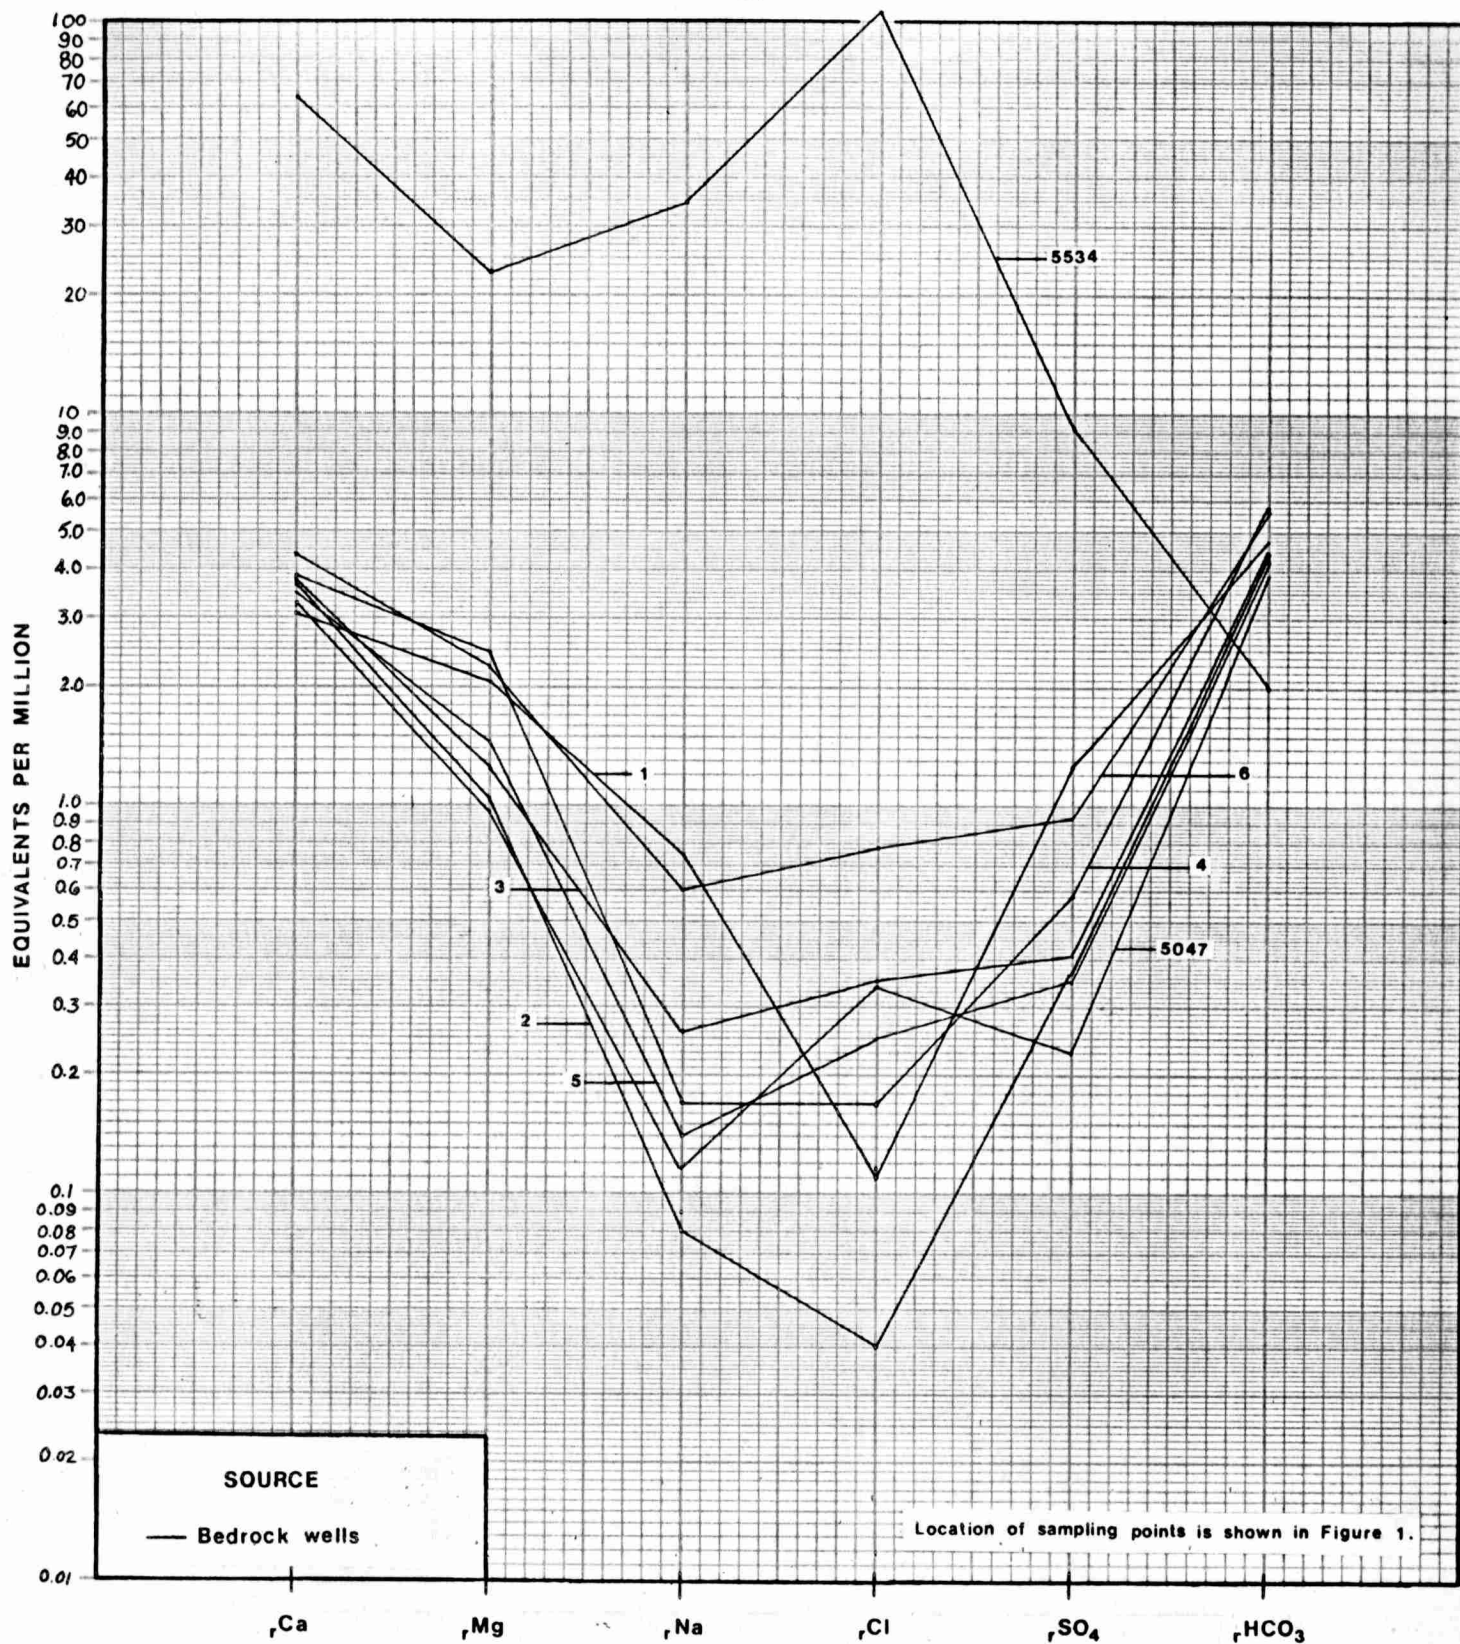
DATE SAMPLED: March 8, 1977

FIGURE 6. SEMI-LOGARITHMIC DIAGRAM OF CHEMICAL ANALYSES OF WATER FROM THE BEDROCK AQUIFER.

In general, similar chemical trends are exhibited by the springs, shallow wells and the surface water runoff. Indeed, all three analyses (Figures 6 to 8) indicate the influence the feedlot runoff is having on the quality of surface water runoff and on the shallow groundwaters.

No significant changes in chemical quality occurred in this aquifer between two sampling dates (March 8, 1977 and November, 1977) as indicated by Figures 6 to 8.

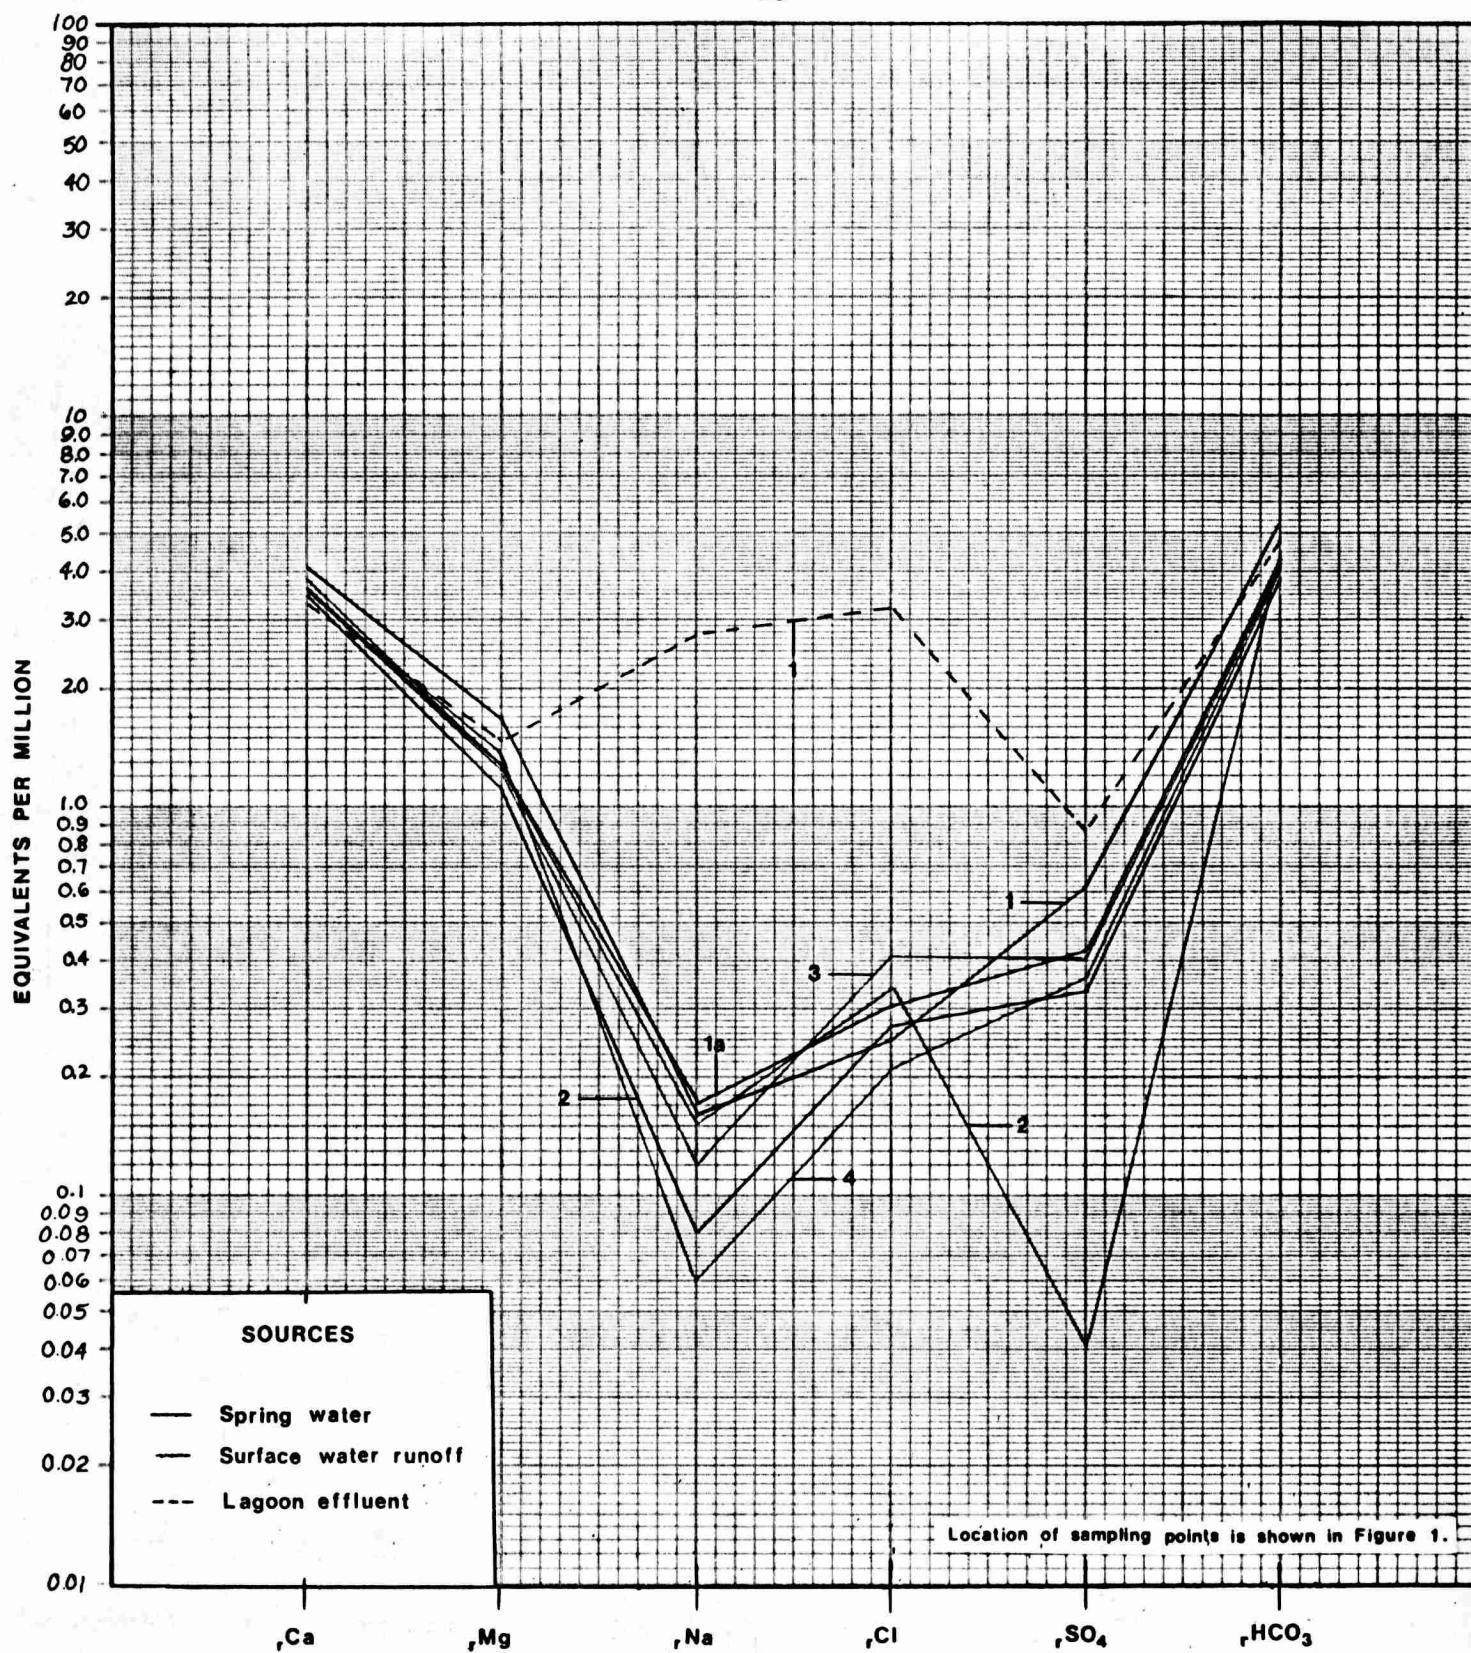
DATE SAMPLED: March 8, 1977

FIGURE 7. SEMI-LOGARITHMIC DIAGRAM OF CHEMICAL ANALYSES OF SPRING AND STREAM WATERS AND OF LAGOON EFFLUENT.

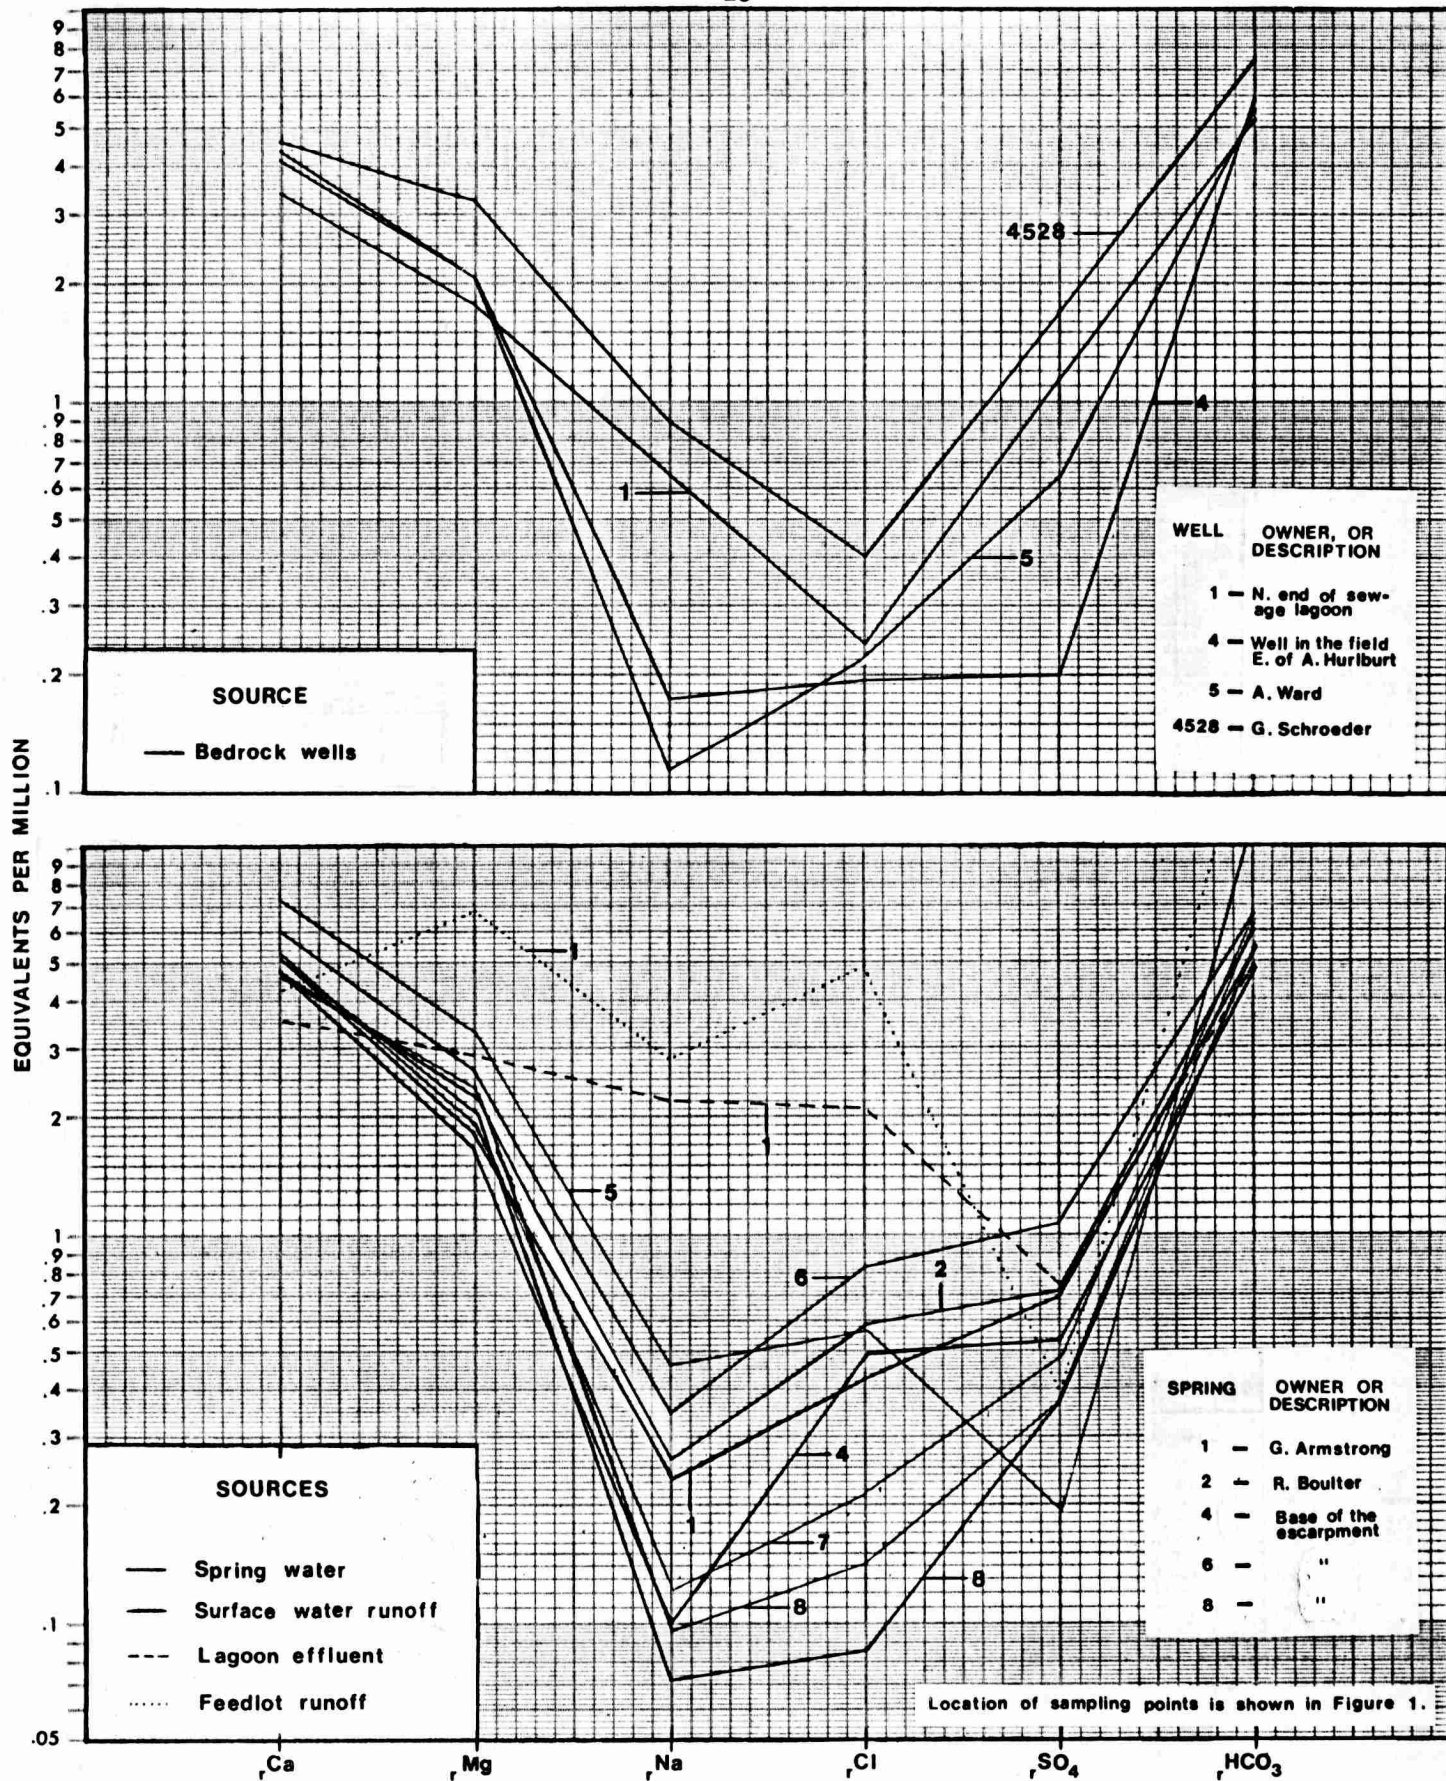
FIGURE 8. SEMI-LOGARITHMIC DIAGRAM OF CHEMICAL ANALYSES  
WITHIN THE STUDY AREA.
